# NEWBURGH/NEW WINDSOR WATERSHEDS PROJECT

Final report on current conditions and proposed  
remediation actions for the Silver Stream watershed

*Prepared for the New York State Department of Environmental  
Conservation by Students of Cornell University's College of Art  
Architecture and Planning as part of CRP 3072/5072:  
Environmental Planning Workshop*

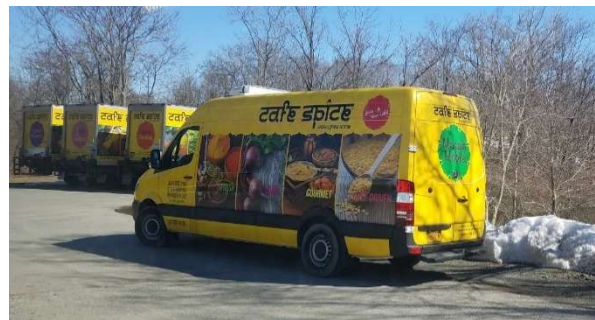
Figure 2: Cafe Spice Truck at Distribution Center  
677 Little Britain Road

Cafe Spice distribution center on Little Britain road is at the top of a small hill to the northwest of a pond. The parking lot is flat and appears to be without any drains, barriers, or on-site storm water management and consequentially parking lot runoff goes into the pond. In the event of an accident, there could be substantial quantities of spices draining into the pond and disrupt the natural balance of the water. Locations such as this should manage runoff on-site and prevent

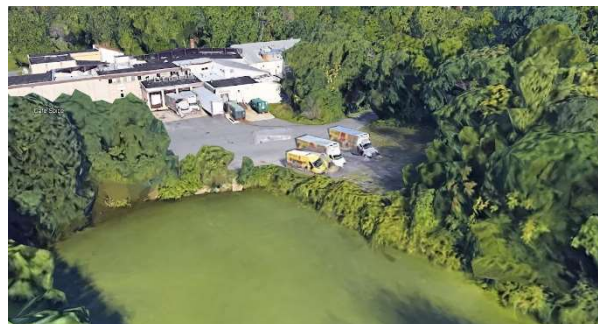
Figure 3: Google Earth overview of Cafe Spice & Pond  
Source: Google Earth

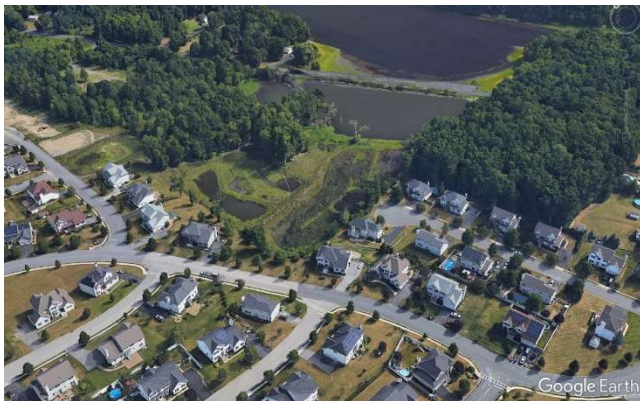
**Figure 4: Google Earth overview of The Reserve, facing east towards the runoff collection ponds and Brown's Pond**

In addition to Union avenue, the Silver Stream watershed has instances of well-managed storm water. An excellent example of this is the "The Reserve" neighborhood on the southeastern tip of Brown's Pond. In this newer tract home development there is both collection and treatment of the storm water. In the neighborhood, there is a self-contained system of drains and a multi-stage series of

filtration ponds adjacent to Brown's Pond. The exact nature of the drains and system isn't publicly available since The Reserve is a private community but after mapping the drains and outflows it appears to be similar to public projects.

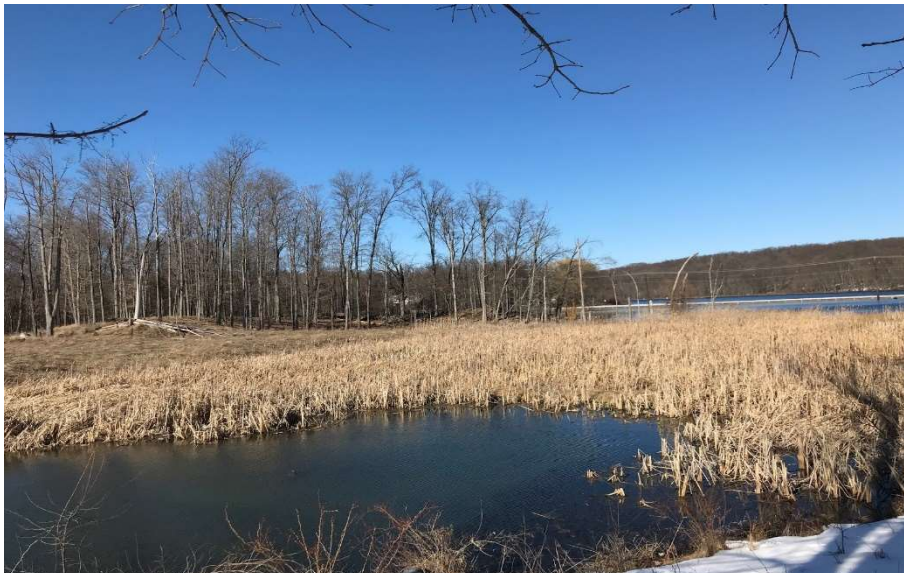
**Figure 5: A view one of the reserve's detention ponds from Reserve Run Rd. Note the Mt. Aris Rd Causeway across Brown's Pond in the background.**

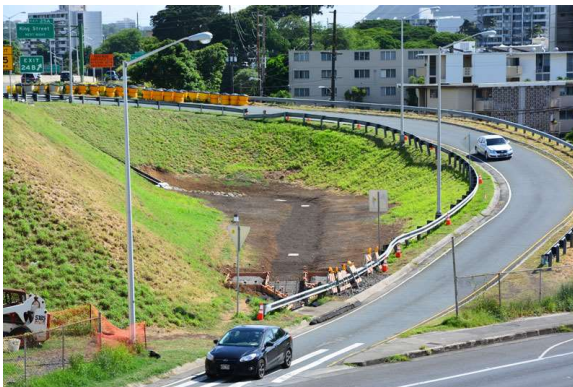
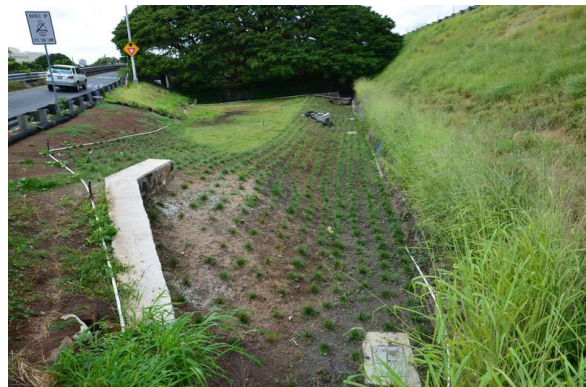
Figure 11: For the Ala Wai Watershed Storm water BMPs on Oahu Project, median areas between the freeway off ramps, were converted into bioswales. The bioswales consist of an under drain system, which includes a perforated drain pipe and engineered soils that provide filtering. Above this, native vegetation was planted to slow and filter storm water as it first enters the bioswales. Additionally, the design includes an outfall structure that forces storm water to pond in the median allowing more time for infiltration into the under drain or evaporation.

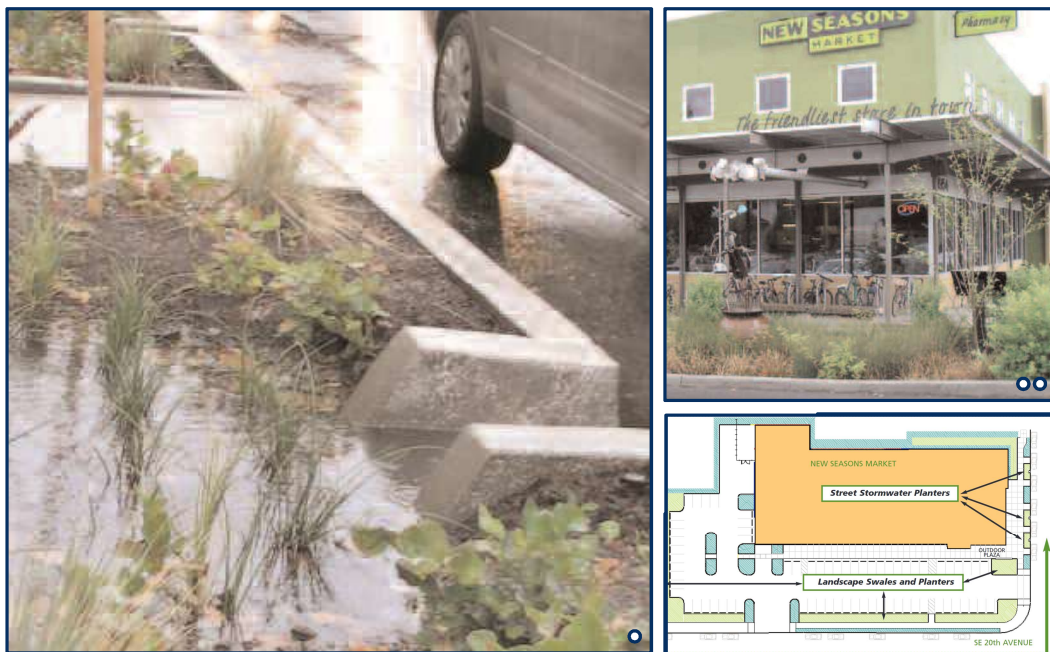
Figure 13: New Seasons Market in Portland, Oregon, installed a ring of interconnected storm water swales. Three storm water planters within a 6-foot planting strip between the sidewalk and street curb slows and filters runoff from Division Street.

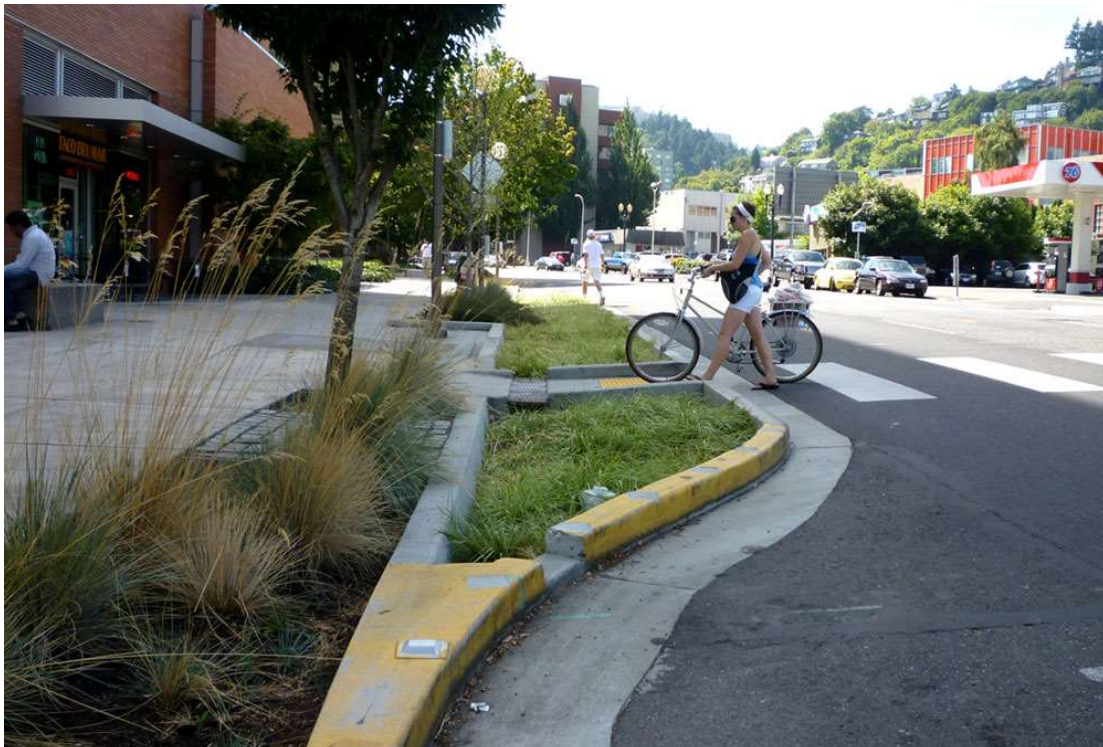
**Figure 15: Sustainable Jersey awarded the City of Hoboken a Sustainable Jersey Small Grant for rain garden curb extensions. Rain garden curb extensions will help New Jersey reach set sustainability goals of alleviating flooding by capturing stormwater runoff and further promoting walking through safer pedestrian crossings**

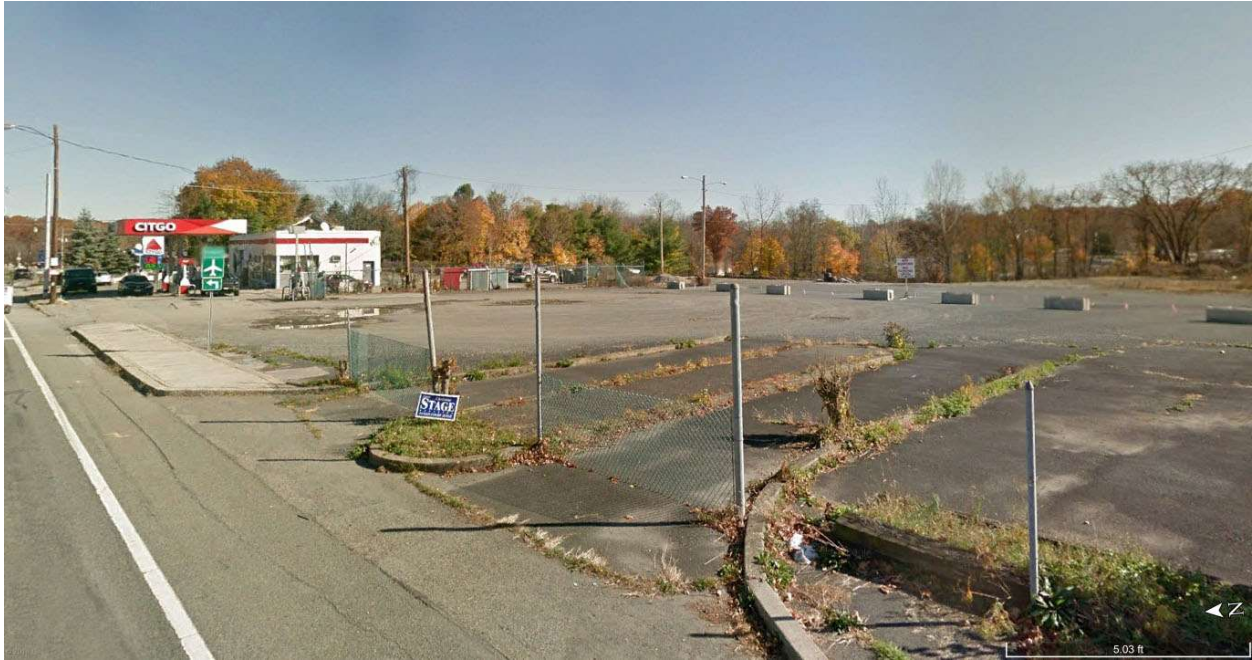
Figure 17: The site as it exists today, viewed from Little Britain Road

The Stewart Citgo Gas Station is located off of Little Britain Road, North of Browns Pond. It has stood there for over two decades as a gas station, the property barren, and largely devoid of vegetation. Heavy metals and toxic chemicals are constant concerns with parking lots and gas station making this site a prime candidate for storm water filtration systems. Storm water management is necessary on this site because of its proximity to a culvert (on the west side of the site) which directs a natural stream into Browns Pond. Water retention and filtration on the site can be used by both the gas station and the housing development southeast of the gas station.

Along the west boundary of the site, the topography naturally slopes to a small stream that feeds into the Silver Stream Reservoir. Behind the gas station, there is an unpaved patch of dirt compacted by heavy vehicle traffic but currently remains unoccupied. The majority of the site is paved but only two thirds of the site appears to be actively used. Curbing near the street is minimal and is completely paved in concrete.

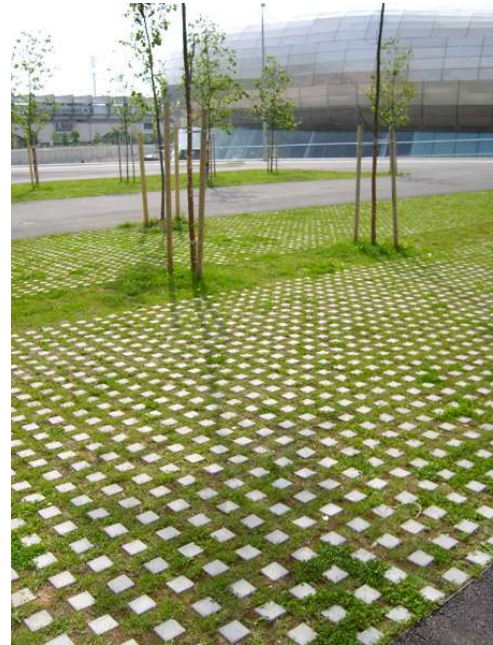
**Figure 18: Permeable Pavers**  
Source: <http://bit.ly/silverfigD2>

The paved western corner of the gas station has minimal traffic. Our second recommendation is to repave this portion of the lot using porous asphalt or turf block pavers that can support vegetation while providing enough stability for vehicles when needed. Part of the asphalt paving will be replaced with these alternative paving methods which will reduce instant runoff into the stream, which will reduce flooding. In addition, water that does enter the stream will be cleaner.

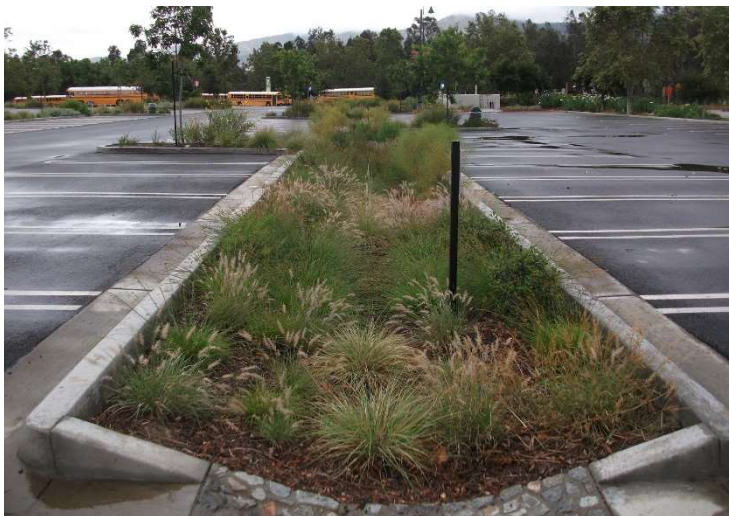
**Figure 19: Bioswale**  
Source: <http://bit.ly/silverfigD3>

The rear portion of the lot is a large, packed-dirt surface. We propose that the city work with the owners to develop part of this lot into a bioswale. This intervention would not only filter pollutants but retain and treat the water running off the site. Additionally, this bioswale could help treat pollutants running off the neighborhood development just behind the gas station.
